Manhole Inspection Summary

Manhole # S21I__023MH

Insp Date: **9/20/07 2:43 PM**

Location Address: **1841 FREDICK AVE**

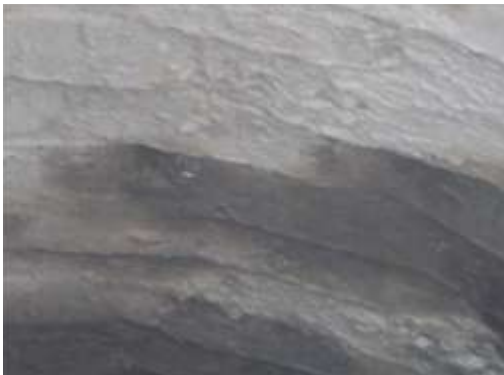
Defect 3

Surcharge ☐ Evidence Of Surcharge Depth: (ft.) ☐ Active Surcharge Present

SURCHARGE EVIDENCE

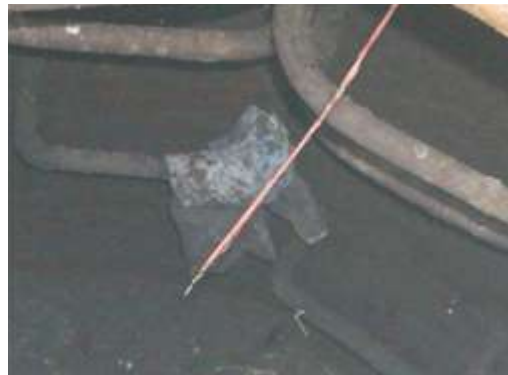
Defect 2

Infiltration: ☐ None ☐ Joint ☐ Cracks ☐ Mortar ☐ Roots ☒ Wall

CORBEL INFILTRATION

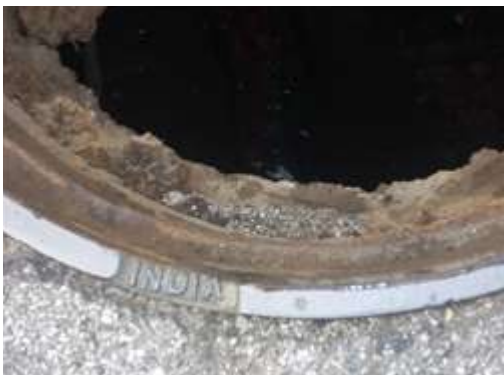
Defect 1

SURCHARGE EVIDENCE

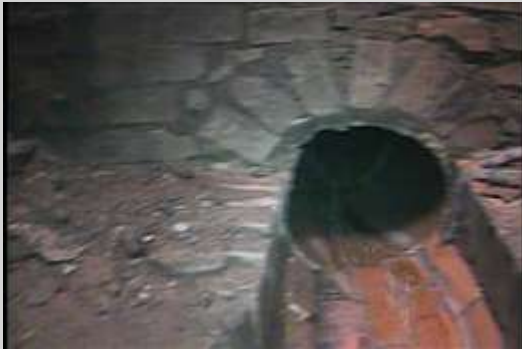
12 O'Clock Outflow

10 in. Circular Gravity Sewer
Pipe Out @ 12 O'Clock

Pipe Height: **9.6** (in.) Rod and Bar (Angled)
Pipe Material: **Clay** ☐ Pipe Lined
Invert Depth: **11.59** (ft.) Flow Characteristics: **Slow**
Deposits: ☒ None ☐ Mud ☐ Sludge ☐ Debris ☐ Grease
Silt Depth: (in.) Deposits Extent:
Infiltration: **None** Pipe Seal Cond: **Sound**

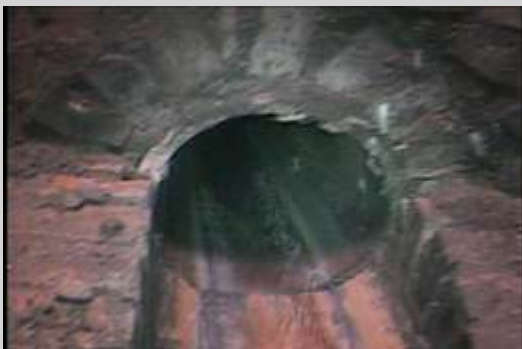
6 O'Clock Inflow

10 in. Circular Gravity Sewer
Pipe In @ 6 O'Clock

Pipe Height: **10.8** (in.) Rod and Bar (Angled)
Pipe Material: **Clay** ☐ Pipe Lined
Invert Depth: **11.53** (ft.) Flow Characteristics: **Slow**
Deposits: ☒ None ☐ Mud ☐ Sludge ☐ Debris ☐ Grease
Silt Depth: (in.) Deposits Extent:
Infiltration: **None** Pipe Seal Cond: **Sound**
